Village of Irvington Town Hall Exterior Conditions Analysis
85 Main Street
Irvington, NY 10533

October 11, 2012

Exterior Conditions Analysis Irvington Town Hall

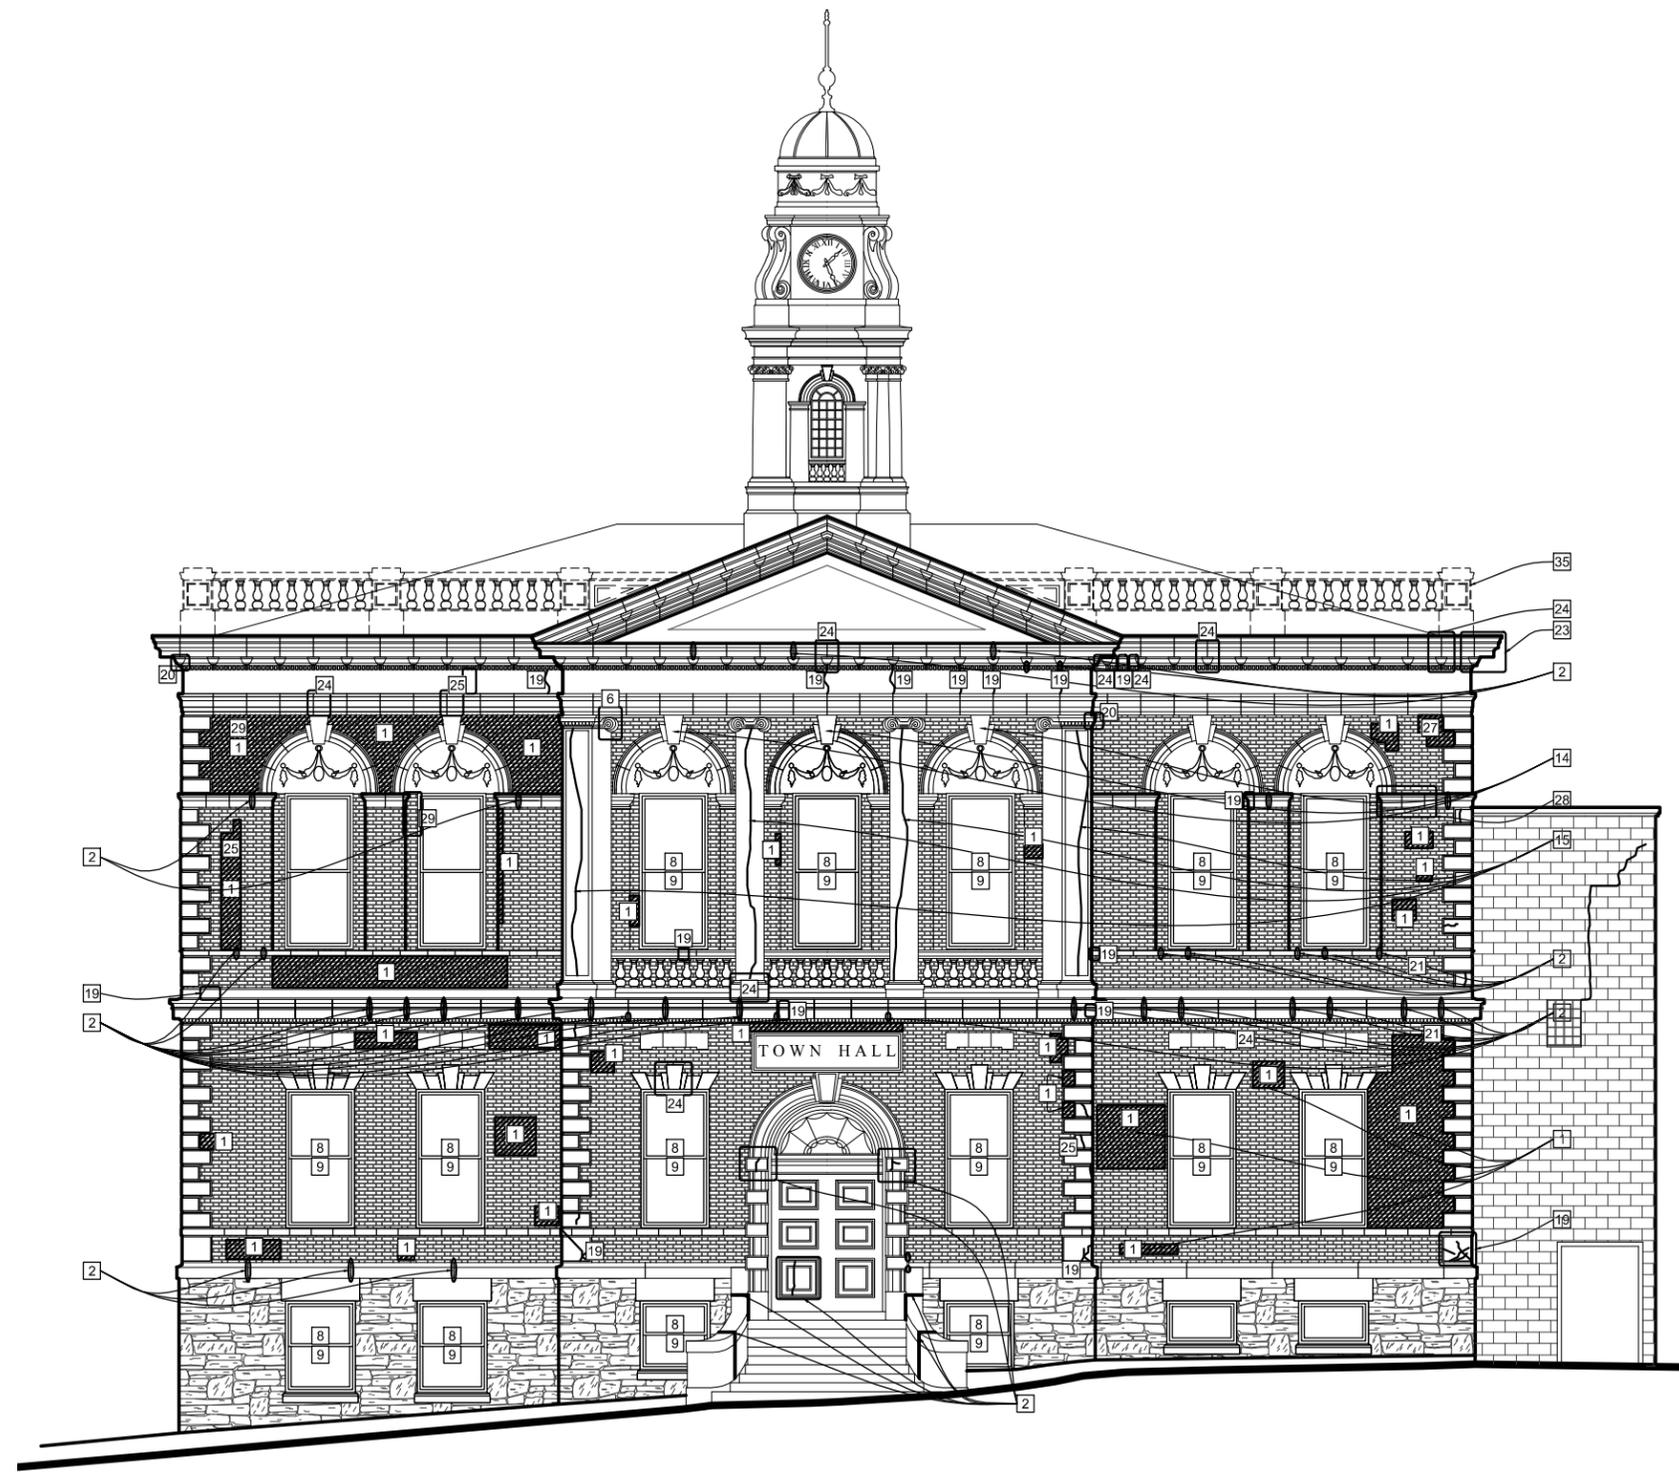
1 SOUTH ELEVATION (FRONT FACADE)
3/32" = 1'-0"

1. REPOINTING/EXTENSIVE ERODING OF ORIGINAL POINTING OF MASONRY, (REFERENCE PHOTO 18, 56, 57, 58, 59, 62, 68)
2. DETERIORATED JOINT CONDITION
3. CHIPPED/CRACKED MASONRY

4. OFFSET TILE AND OR TILE DISCOLORATION
5. FAILING JOINTS
6. BROKEN OFF CAPITAL VOLUTE (REFERENCE PHOTO 24)
7. NOT USED
8. EXISTING TRIM AND PAINT IN POOR CONDITION, CONTAINS LEAD BASED PAINT (LBP) (REFERENCE PHOTO 19, 20)

9. EXISTING CAULK JOINT IN POOR CONDITION (REFERENCE PHOTO 19, 20, 25, 26)
10. JOINTS IN POOR/FAIR CONDITION
11. JOINTS IN FAIR/GOOD CONDITION
12. JOINTS IN POOR CONDITION (REFERENCE PHOTO 63, 64, 70)

13. DETACHING VENT
14. TERRA COTTA DISCOLORATION. IN GENERAL TERRA COTTA REVIEWED WAS IN FAIR CONDITION (EXCLUDING SOUTH COLUMNS) HOWEVER AN ALLOWANCE SHOULD BE KEPT FOR DISCOLORATION AND REPAIR OF PREVIOUSLY PATCHED AREAS. (REFERENCE PHOTO #12)

15. TERRA COTTA COLUMNS AND PILASTERS IN THE PORTICO ARE IN POOR CONDITION. THE BASE AND CAPITALS ARE ALSO IN POOR CONDITION WITH VISUAL SIGNS OF EXTENSIVE CRACKING. (REFERENCE PHOTO 1, 2, 9, 40, 41, 42, 61)

16. STEPPED CRACKS THAT RUN THROUGH THE EXISTING CMU MORTAR JOINTS. (REFERENCE PHOTO 8, 65)
17. PREVIOUSLY PATCHED AREA
18. OPEN JOINT FROM REMOVED FIRE ESCAPE

19. CRACKED TERRA COTTA (REFERENCE PHOTO 28, 29, 30, 31, 33, 34, 36, 37, 39, 45, 46, 47, 48, 49, 51, 74)
20. SPALLED TERRA COTTA (REFERENCE PHOTO 39, 55, 60)

21. PRESENCE OF EFFLORESCENCE (REFERENCE PHOTO 21, 22, 23)
22. DETERIORATING/OPEN CONTROL JOINT BETWEEN STRUCTURES
23. PREVIOUSLY PATCHED AND PINNED AREA. IN POOR CONDITION (REFERENCE PHOTO 10, 11)

24. LOOSE MASONRY UNIT (REFERENCE PHOTO 5, 12, 27, 28, 29, 30, 31, 32, 33, 35, 38, 43, 44, 52, 60, 67)
25. PREVIOUSLY PATCHED AREA (REFERENCE PHOTO 50, 57, 58, 59)

26. STEEL BEAM IS EXPOSED AND DETERIORATING (REFERENCE PHOTO 8)
27. PATCHED AREA THAT SOUNDS AND FEELS LOOSE (REFERENCE PHOTO 6, 7, 13, 14)
28. MASONRY UNITS THAT SOUND LOOSE (REFERENCE PHOTO 15, 16, 17, 19, 29, 30, 31)

29. DISPLACED BRICK (REFERENCE PHOTO 53, 54)
30. PREVIOUSLY PATCHED WINDOW HEAD (REFERENCE PHOTO 66)
31. EXPOSED PIPE AND ASSOCIATED LOOSE BRICK (REFERENCE PHOTO 69)

32. (REFERENCE PHOTO 71)
33. WOODEN LOUVER PAINT FINISH IS PEELING AND CHIPPING (REFERENCE PHOTO 75)
34. EXISTING WOOD DOOR AND TRIM PAINT CONTAINS LBP (REFERENCE PHOTO 76)

35. LOCATION OF ORIGINAL 1902 TERRA COTTA BALUSTRADE SINCE BEEN REMOVED, REFERENCE HISTORICAL PHOTO IN SECTION C
