Village of Irvington Town Hall Exterior Conditions Analysis
85 Main Street
Irvington, NY 10533

October 11, 2012

Exterior Conditions Analysis Irvington Town Hall

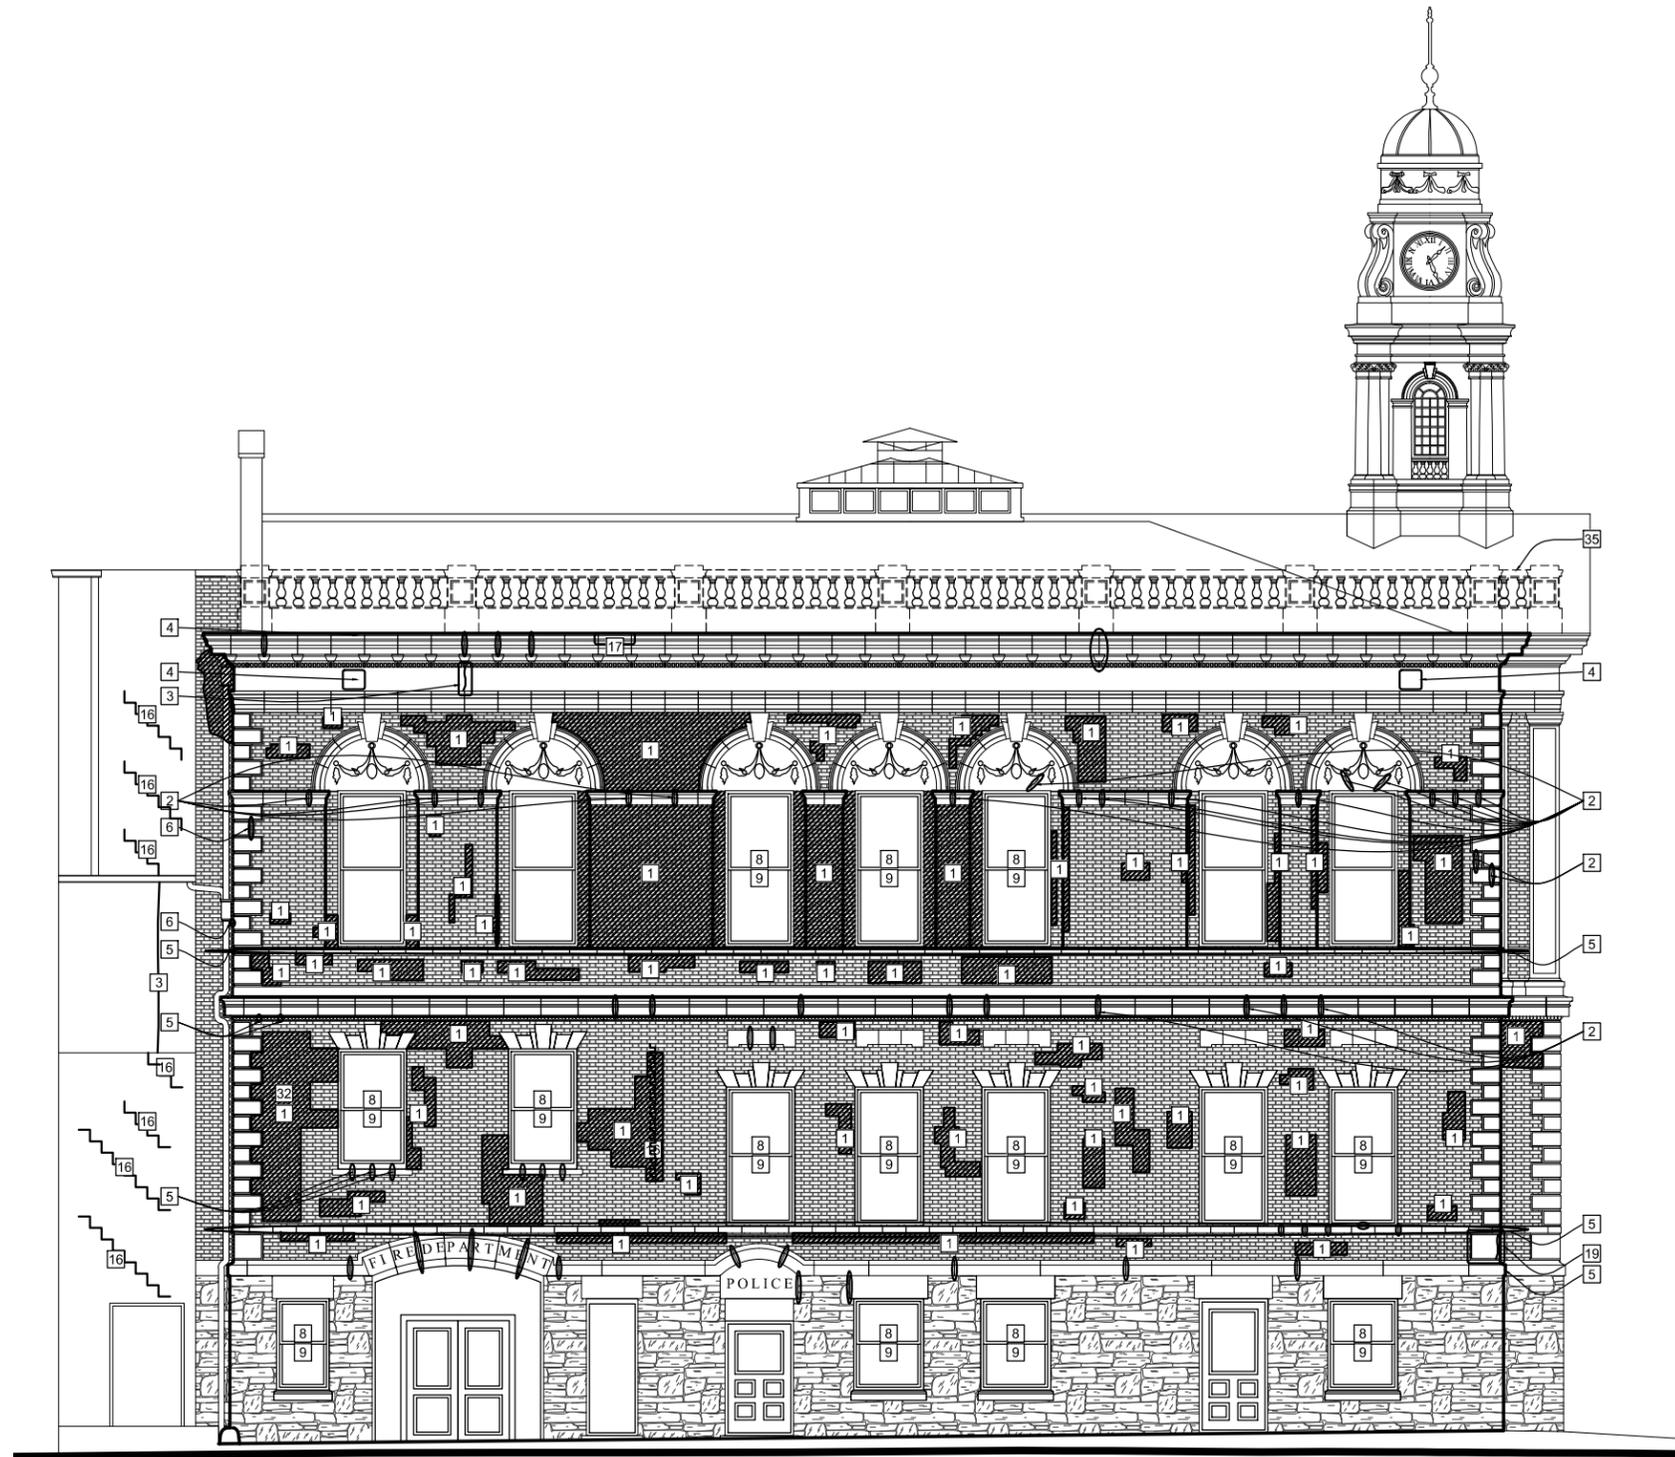
| 1. REPOINTING/EXTENSIVE ERODING OF ORIGINAL POINTING OF MASONRY, (REFERENCE PHOTO 18, 56, 57, 58, 59, 62, 68) | 13. DETACHING VENT |
| | 34. EXISTING WOOD DOOR AND TRIM PAINT CONTAINS LBP (REFERENCE PHOTO 76) |
| | 35. LOCATION OF ORIGINAL 1902 TERRA COTTA BALUSTRADE SINCE BEEN REMOVED, REFERENCE HISTORICAL PHOTO IN SECTION C |

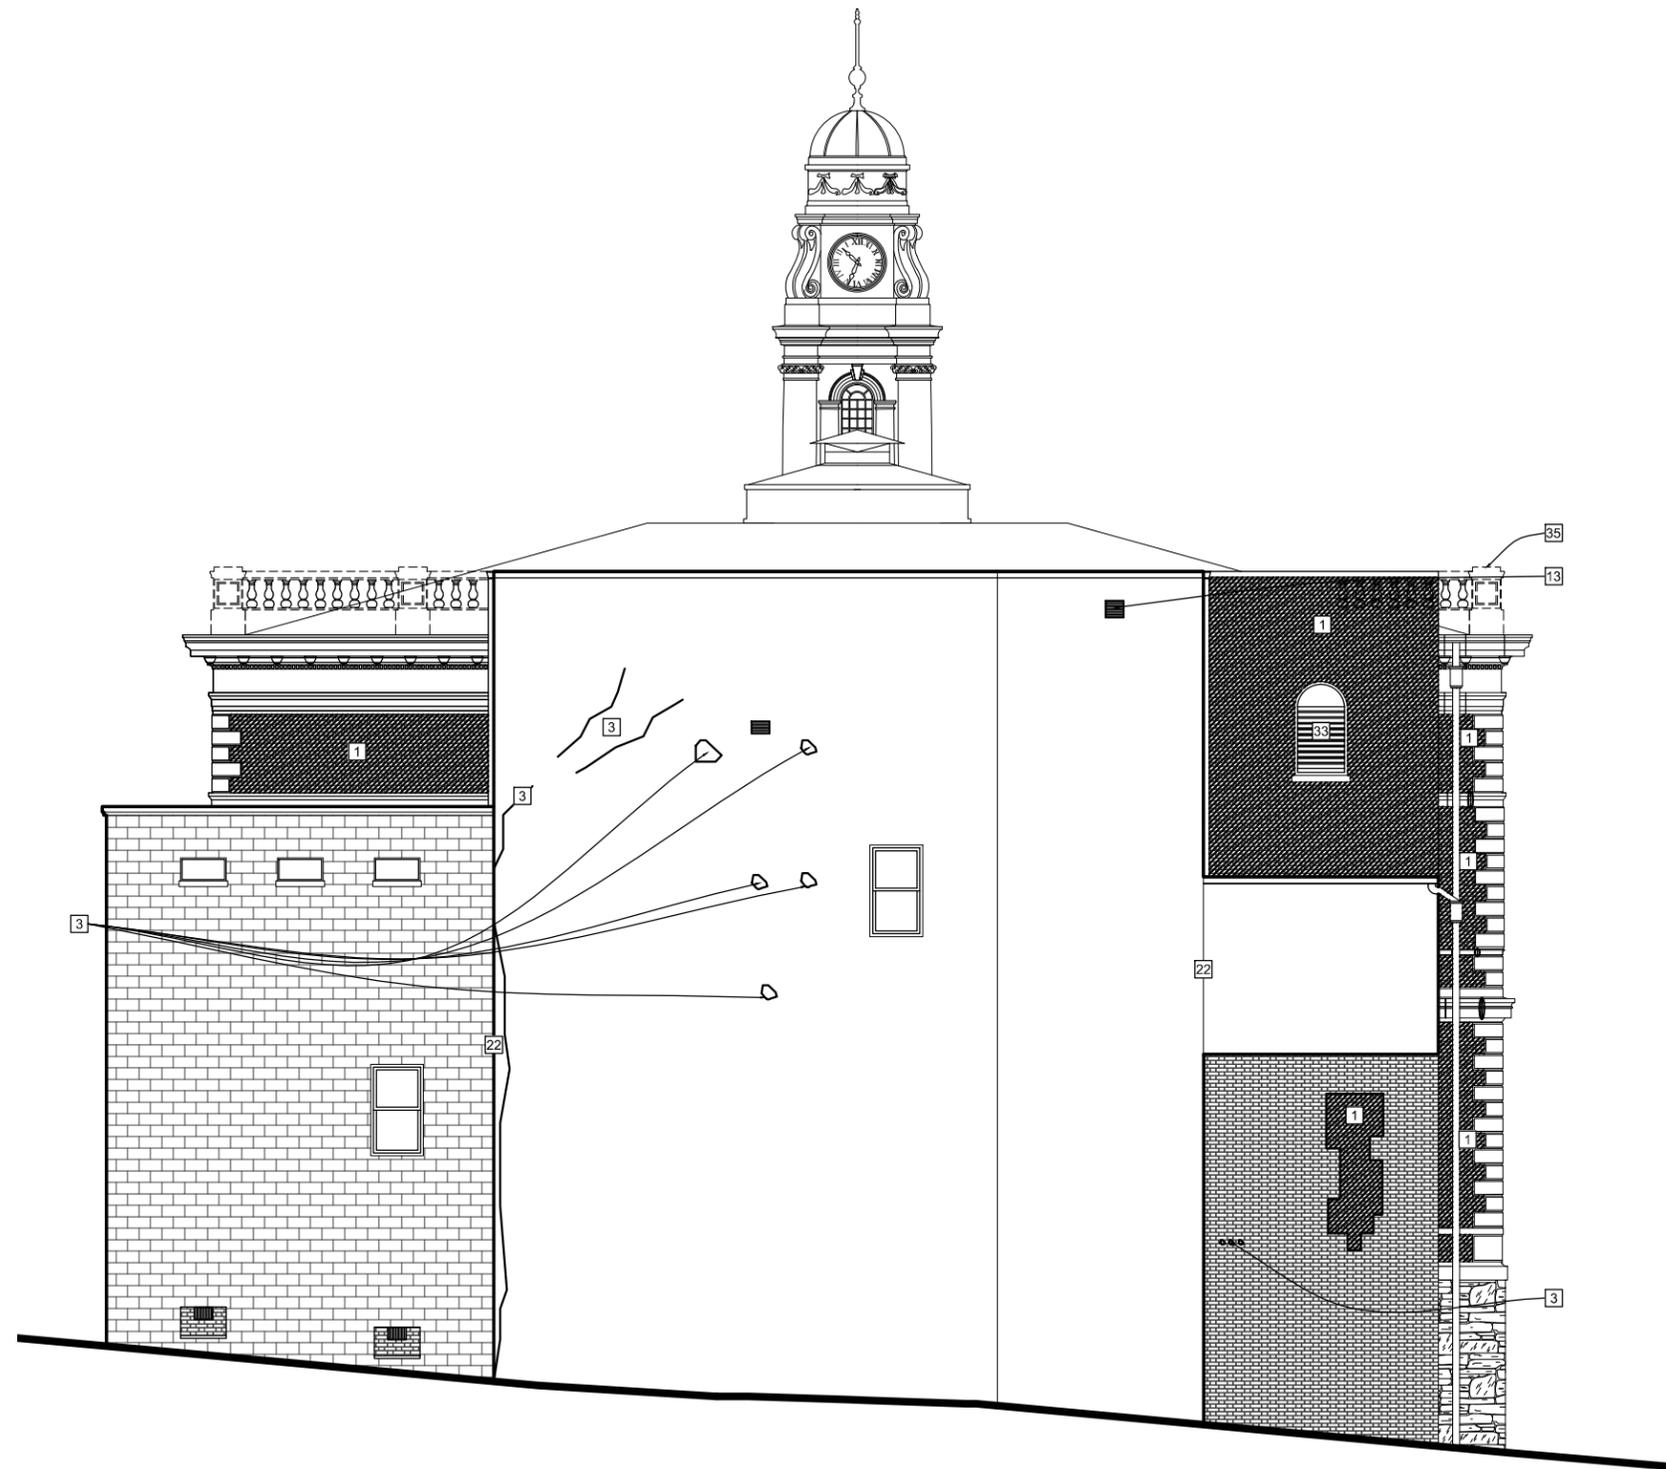
ELEVATION NOTES:
PHOTOS REFERENCE SECTION 6

| <p>1. REPOINTING/EXTENSIVE ERODING OF ORIGINAL POINTING OF MASONRY, (REFERENCE PHOTO 18, 56, 57, 58, 59, 62, 68)</p> <p>2. DETERIORATED JOINT CONDITION</p> <p>3. CHIPPED/CRACKED MASONRY</p> <p>4. OFFSET TILE AND OR TILE DISCOLORATION</p> <p>5. FAILING JOINTS</p> <p>6. BROKEN OFF CAPITAL VOLUTE (REFERENCE PHOTO 24)</p> <p>7. NOT USED</p> <p>8. EXISTING TRIM AND PAINT IN POOR CONDITION, CONTAINS LEAD BASED PAINT (LBP) (REFERENCE PHOTO 19, 20)</p> <p>9. EXISTING CAULK JOINT IN POOR CONDITION (REFERENCE PHOTO 19, 20, 25, 26)</p> <p>10. JOINTS IN POOR/FAIR CONDITION</p> <p>11. JOINTS IN FAIR/GOOD CONDITION</p> <p>12. JOINTS IN POOR CONDITION (REFERENCE PHOTO 63, 64, 70)</p> | <p>13. DETACHING VENT</p> <p>14. TERRA COTTA DISCOLORATION. IN GENERAL TERRA COTTA REVIEWED WAS IN FAIR CONDITION (EXCLUDING SOUTH COLUMNS) HOWEVER AN ALLOWANCE SHOULD BE KEPT FOR DISCOLORATION AND REPAIR OF PREVIOUSLY PATCHED AREAS. (REFERENCE PHOTO #12)</p> <p>15. TERRA COTTA COLUMNS AND PILASTERS IN THE PORTICO ARE IN POOR CONDITION. THE BASE AND CAPITALS ARE ALSO IN POOR CONDITION WITH VISUAL SIGNS OF EXTENSIVE CRACKING. (REFERENCE PHOTO 1, 2, 9, 40, 41, 42, 61)</p> <p>16. STEPPED CRACKS THAT RUN THROUGH THE EXISTING CMU MORTAR JOINTS, (REFERENCE PHOTO 8, 65)</p> <p>17. PREVIOUSLY PATCHED AREA</p> <p>18. OPEN JOINT FROM REMOVED FIRE ESCAPE</p> <p>19. CRACKED TERRA COTTA (REFERENCE PHOTO 28, 29, 30, 31, 33, 34, 36, 37, 39, 45, 46, 47, 48, 49, 51, 74)</p> <p>20. SPALLED TERRA COTTA (REFERENCE PHOTO 39, 55, 60)</p> <p>21. PRESENCE OF EFFLORESCENCE (REFERENCE PHOTO 21, 22, 23)</p> <p>22. DETERIORATING/OPEN CONTROL JOINT BETWEEN STRUCTURES</p> <p>23. PREVIOUSLY PATCHED AND PINNED AREA. IN POOR CONDITION (REFERENCE PHOTO 10, 11)</p> <p>24. LOOSE MASONRY UNIT (REFERENCE PHOTO 5, 12, 27, 28, 29, 30, 31, 32, 33, 35, 38, 43, 44, 52, 60, 67)</p> <p>25. PREVIOUSLY PATCHED AREA (REFERENCE PHOTO 50, 57, 58, 59)</p> <p>26. STEEL BEAM IS EXPOSED AND DETERIORATING (REFERENCE PHOTO 8)</p> <p>27. PATCHED AREA THAT SOUNDS AND FEELS LOOSE (REFERENCE PHOTO 6, 7, 13, 14)</p> <p>28. MASONRY UNITS THAT SOUND LOOSE (REFERENCE PHOTO 15, 16, 17, 19, 29, 30, 31)</p> <p>29. DISPLACED BRICK (REFERENCE PHOTO 53, 54)</p> <p>30. PREVIOUSLY PATCHED WINDOW HEAD (REFERENCE PHOTO 66)</p> <p>31. EXPOSED PIPE AND ASSOCIATED LOOSE BRICK (REFERENCE PHOTO 69)</p> <p>32. (REFERENCE PHOTO 71)</p> <p>33. WOODEN LOUVER PAINT FINISH IS PEELING AND CHIPPING (REFERENCE PHOTO 75)</p> <p>34. EXISTING WOOD DOOR AND TRIM PAINT CONTAINS LBP (REFERENCE PHOTO 76)</p> <p>35. LOCATION OF ORIGINAL 1902 TERRA COTTA BALUSTRADE SINCE BEEN REMOVED, REFERENCE HISTORICAL PHOTO IN SECTION C</p> |
